## Waterproofing & Water Damage Remediation; Cosmetic Renovation

**Project Challenge:** Identify and correct water intrusion from exterior roof and deck of coastline residence; remediate and restore all interior and exterior water damage; renovate waterproof deck and railing; restucco exterior including adequate ventilation.

**Location:** Newport Beach, California

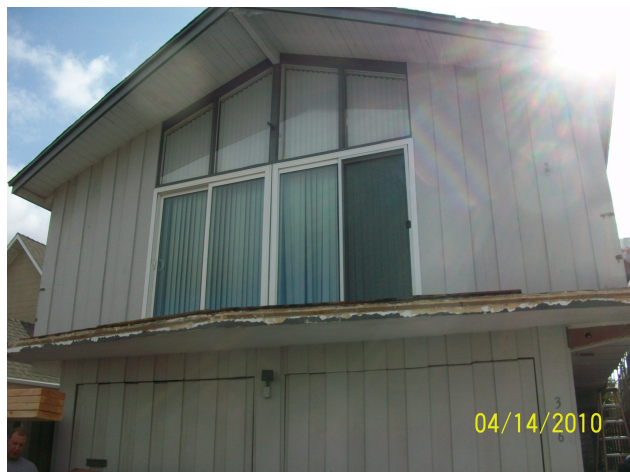
**Before:** Front of house after removing deteriorated railing from water-damaged deck

- ▲ Removed the old roof; rebuilt the overhangs with proper pitch; installed new fascia; installed new 30 year-warranty composition shingle roof; installed new gutters to redirect water away from walkways.
- ▲ Demolished deck and substructure; rebuilt deck with proper slope, drainage, and flashing; and applied long-life waterproof coating. Due to age and condition of structure, we were required to bring the deck to compliance with current Building Code requirements, including handrails.
- ▲ Installed new roll-up garage doors to replace aged and deteriorated solid-panel garage doors.
- ▲ Restuccoed and repainted house exterior.

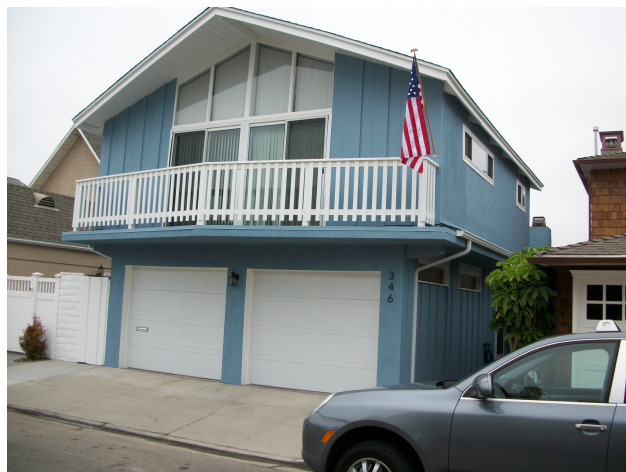
**After:** New waterproof deck, railing, stucco with adequate vents, new garage door, new paint
