Waterproofing & Water Damage Remediation

Project Challenge: Identify and correct numerous sources of water intrusion into coastline residence, and remediate and restore all interior and exterior water damage.

Location: Laguna Beach, California

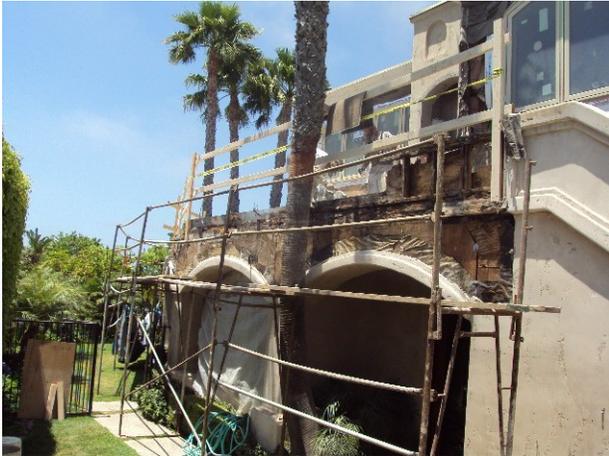
Before: Facade of 14 year-old custom coastal residence (Laguna Beach, CA) with severe damage due to improper waterproofing of parapet wall, etc.

Project Scope: CBCI conducted physical inspection, Infrared diagnostics and destructive testing to identify all sources of water intrusion then completed the following corrective work:

- ▲ Completely demolished one guest house balcony and engineered and reconstructed – including parapet wall, custom ‘cat face’ stucco, glass windscreen, all flashings and sub-tile waterproofing system, and travertine tile deck surface.

- ▲ Demolished 1,000+ square foot main house balcony and engineered and reconstructed – including parapet wall, custom ‘cat face’ stucco, glass windscreen, all flashings and sub-tile waterproofing system, and travertine tile deck surface.

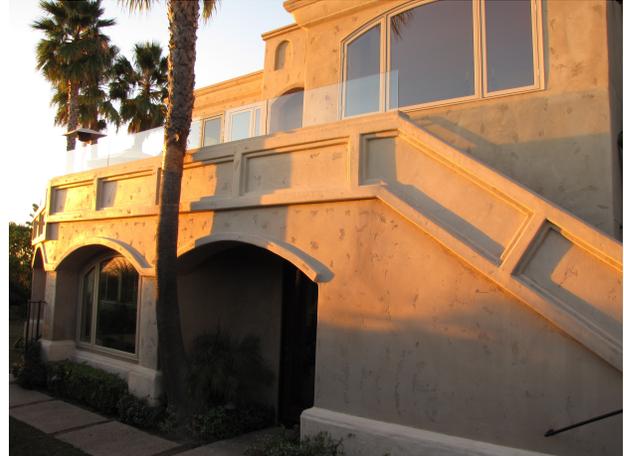
After: Facade of residence after renovations. CBCI repaired/replaced structural wood damage, stucco, windows, parapet wall, seamless glass wind screen, and waterproof deck.
